**Customer XYZ
Sample report**

**2/07/2014
Job #146824**

First Floor Heating Problem Findings

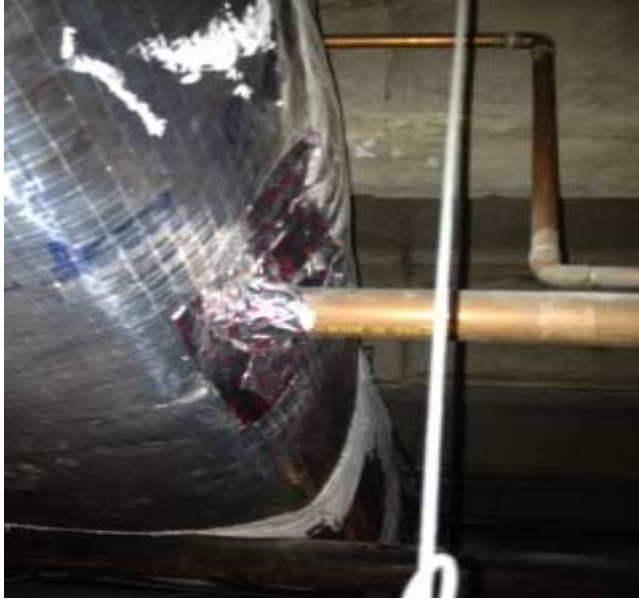
2. Tenant (Suite 175) main branch cold air duct leaking in return fur down area above drop ceiling. Apparent 1.025 copper suction line for previous split system penetrating duct causing 55 degree system supply air mixing with return air.

Pipe penetrating supply air duct in return fur down above first floor tenant ceiling.

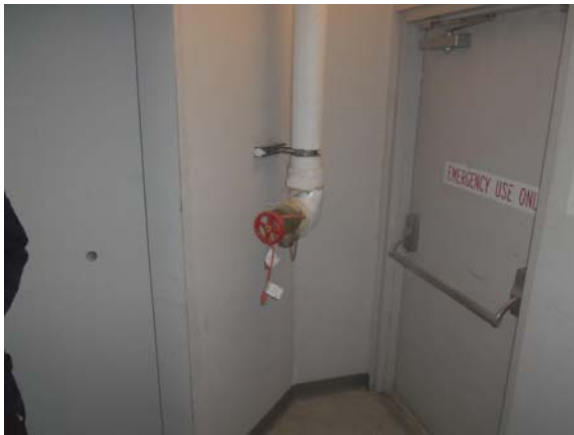
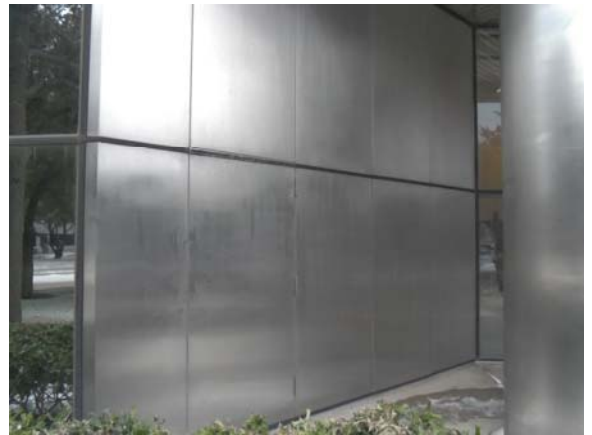
3. North stairwell emergency exit door not properly sealed and leaking outside air into stairwell.

Stairwell and Outside Emergency Door

Outside Exit door

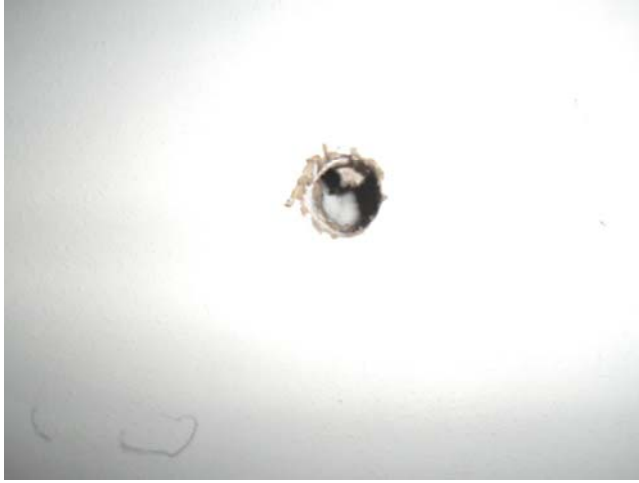
4. Noted no insulation between tenant's north exterior walls and stairwell as seen in thermal scan images (Attached).

Note: Existing Hole in wall. No Insulation in stairwell wall (Adjacent to Office #2)

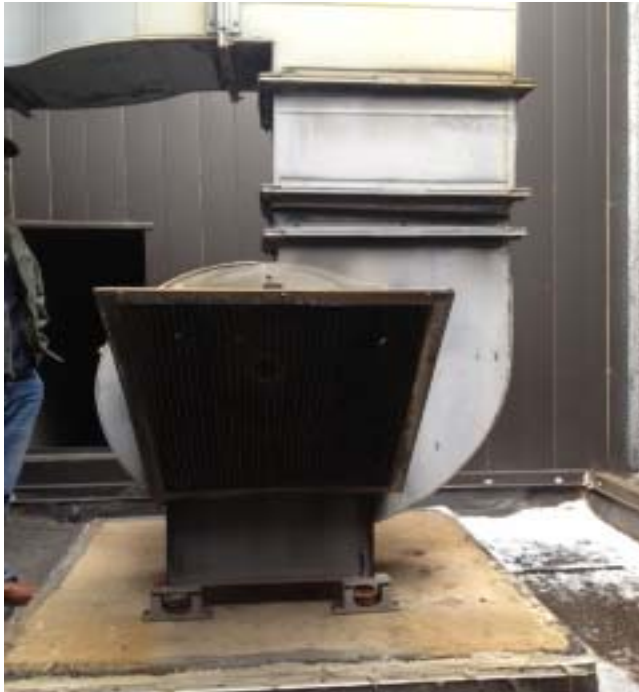
5. Stairwell pressurization fan on roof has no isolation dampers to stairwell intake.

North stairwell pressurization fan intake on roof.

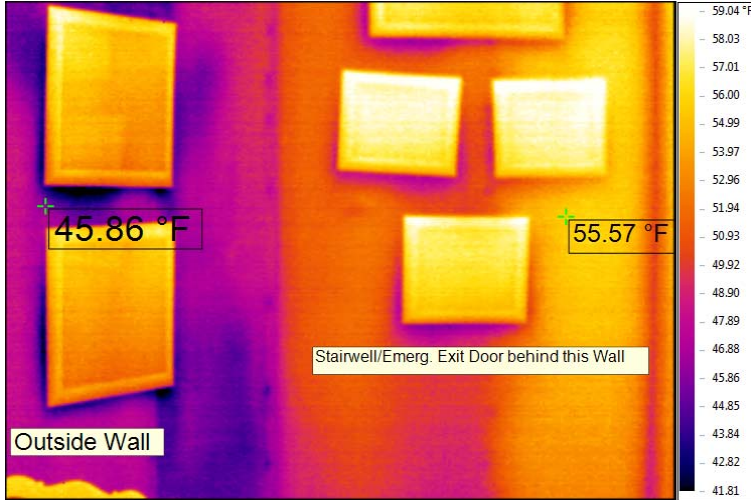
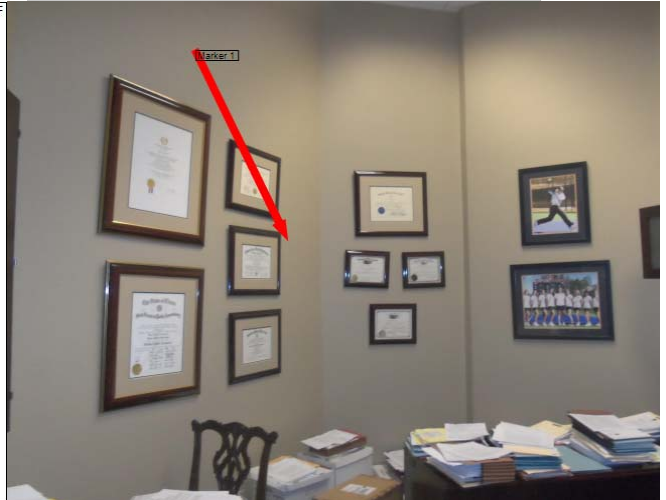
Equipment: Office 2 (2nd on left)

Description: Northwest & North Wall
Note: Angled wall inside Office #2.
Probable Cause: Insulation deficiency in Exterior Wall.
Recommendation: Insulate wall.

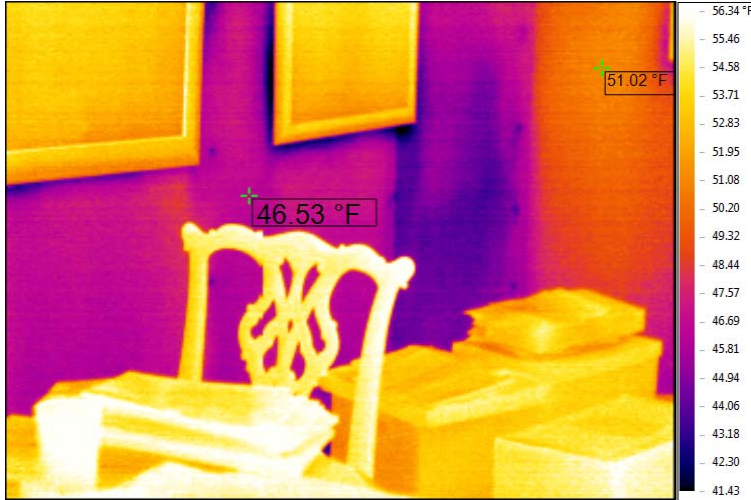
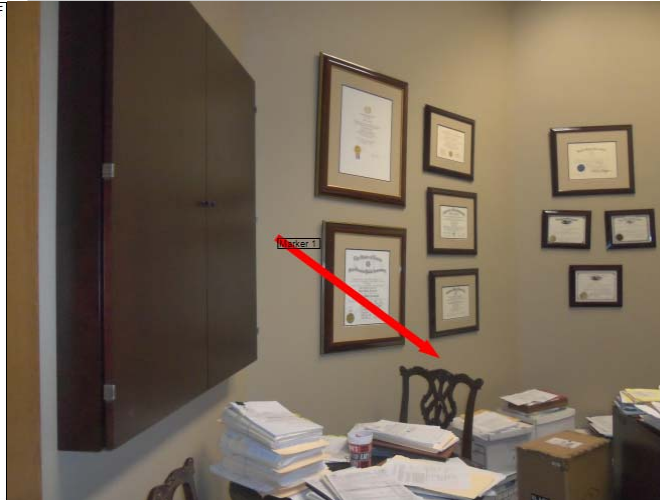
Equipment: Office 2 (2nd on left)

Description: Northwest Wall
Note: Angled wall inside Office #2.
Probable Cause: Insulation deficiency in Exterior Wall.
Recommendation: Insulate wall.

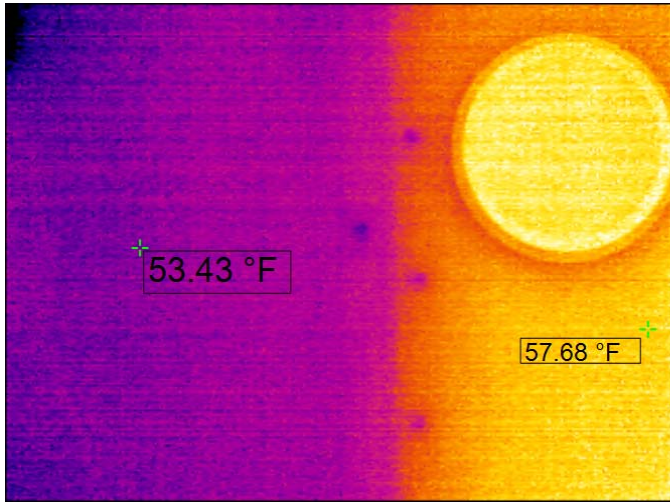
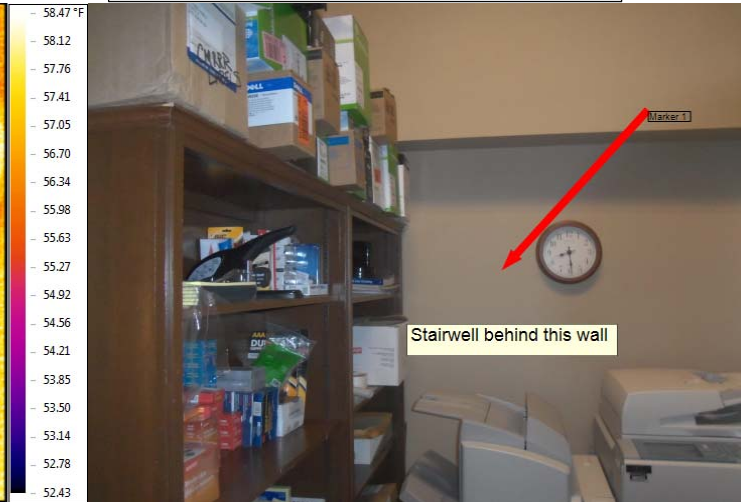
Equipment: Copy Room

Description: North Wall

Probable Cause: Insulation deficiency in Stairwell Wall.

Recommendation: Insulate wall.

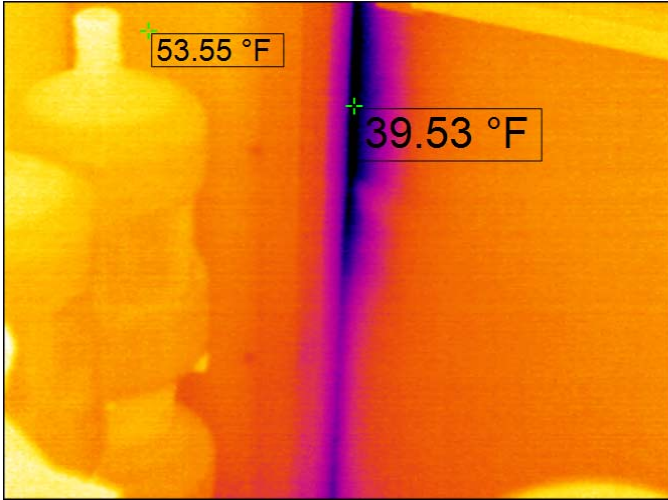
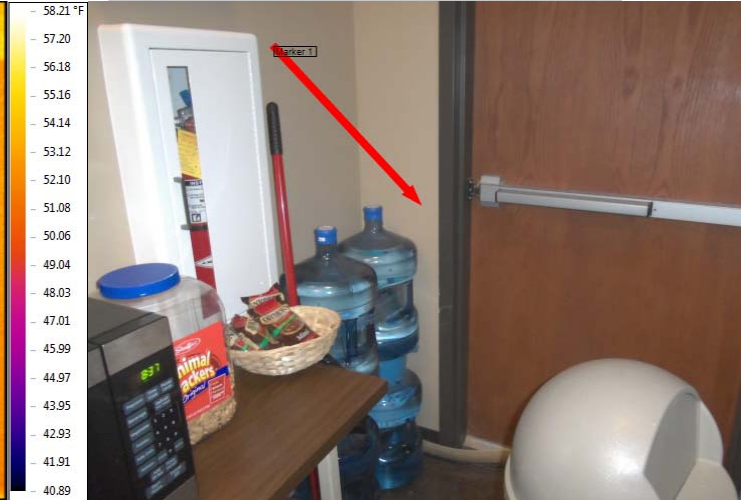
Equipment: Breakroom

Description: Emergency Exit Door to Stairwell

Probable Cause: Insulation deficiency around Emergency Exit door to Stairwell.

Recommendation: Insulate around door and wall.

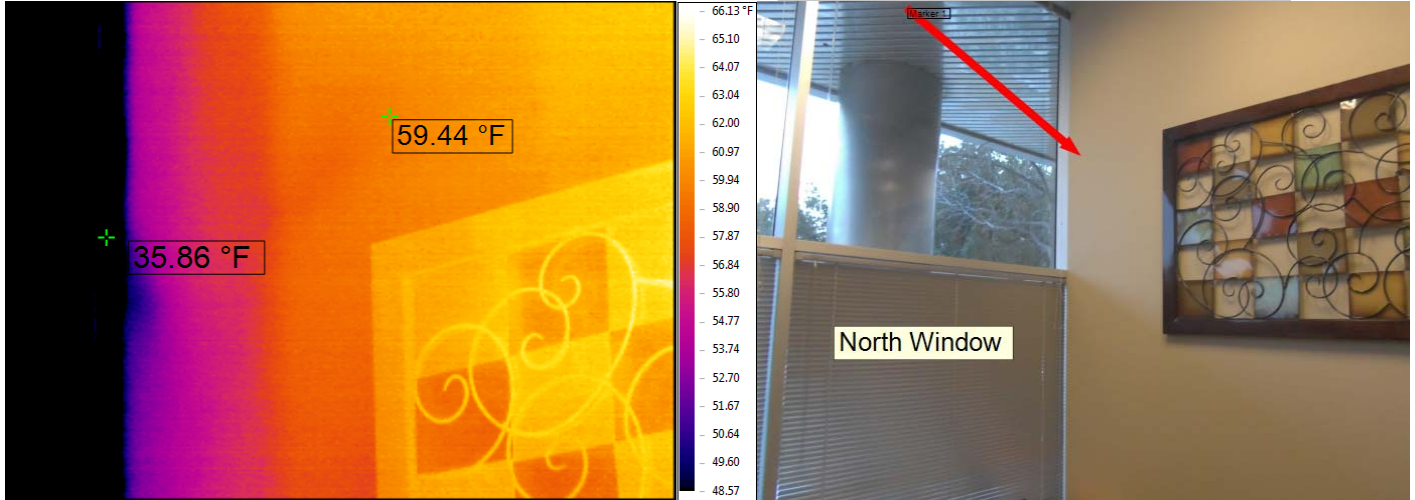
Equipment: Office 1 (38)

Description: East Wall

Probable Cause: Insulation deficiency in exterior wall, and around window. This office is adjacent to Office #2. (See images #1 and #2)

Recommendation: Insulate wall and seal windows.

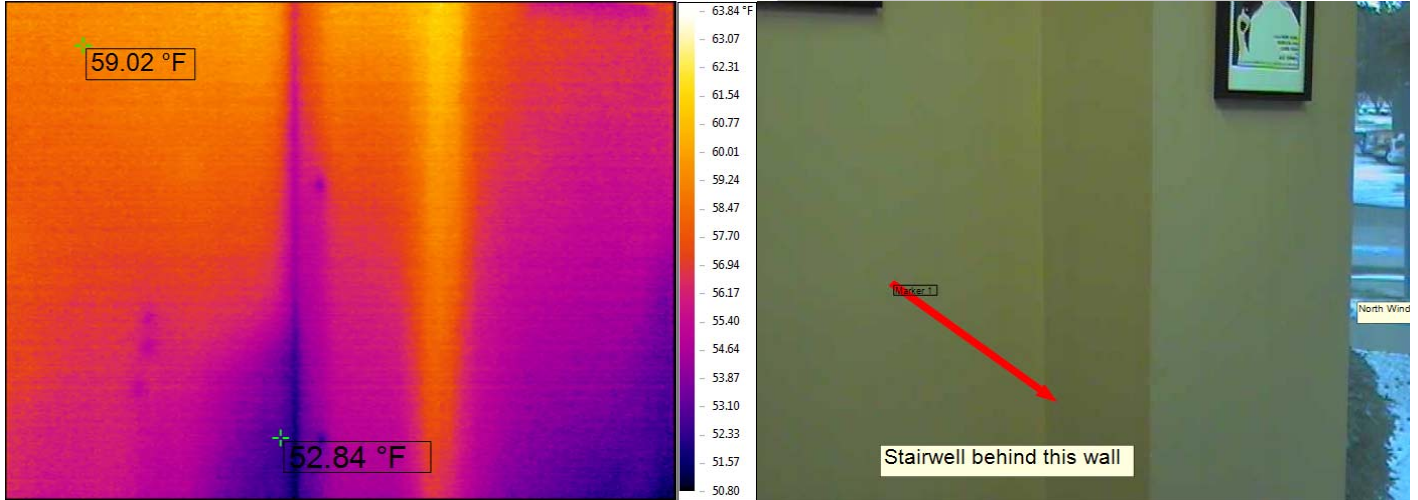
Equipment: Office 3 (NE Side)

Description: West Wall

Probable Cause: Insulation deficiency in Stairwell Wall.

Recommendation: Insulate Wall.

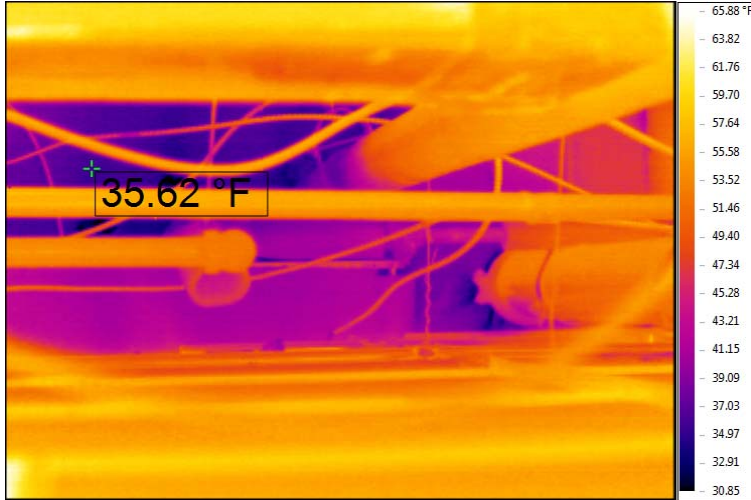
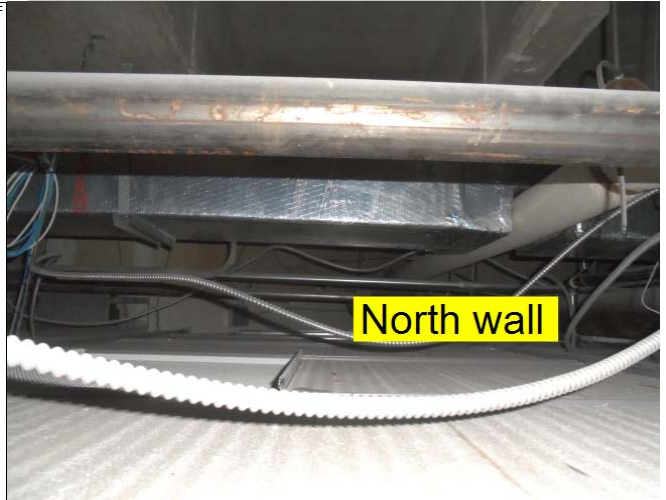
Equipment: Office 2 (2nd on left)

Description: Fur Down (Above Ceiling tiles)
