Roof Problem Details Report

Site: Campfire USA

Equipment: Old Building - North End

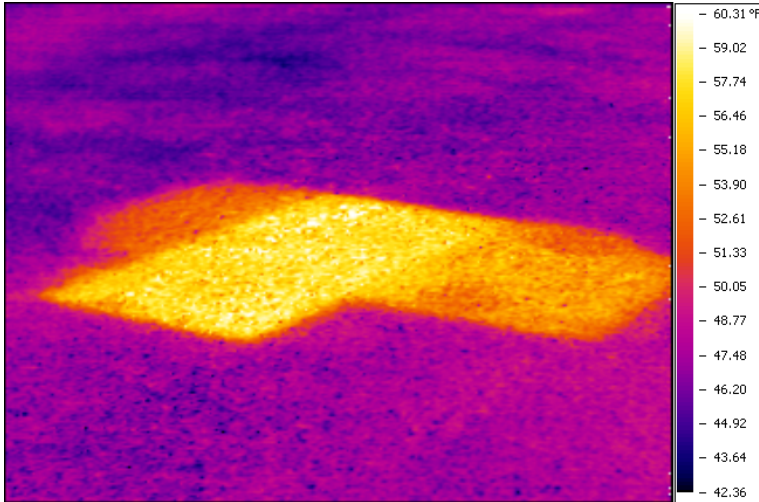
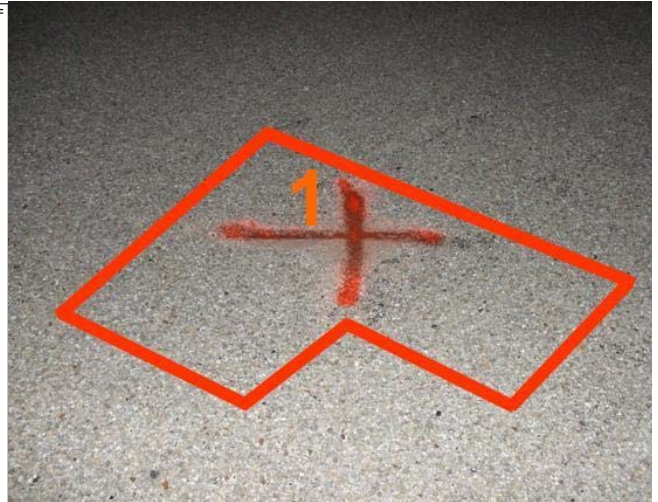
Component: Northwest Side - North side of Old building

Asset ID: Condition: Inter-ply Moisture

Note: Possible Patch.

Probable Cause: Location showed possible moisture penetration.

Recommendation: Confirm with moisture probe and/or core sample.
