Roof Problem Details Report

Site: Campfire USA

Equipment: Old Building - North End

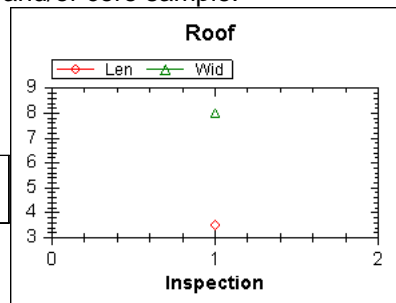
Component: Northwest Side - North side of Old building

Asset ID: Condition: Inter-ply Moisture

Note: Possible Patch.

Probable Cause: Location showed possible moisture penetration.

Recommendation: Confirm with moisture probe and/or core sample.
